# SAFETY ALERT No.2

## Lifting Chains

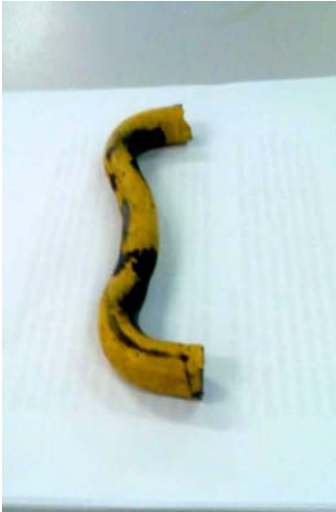
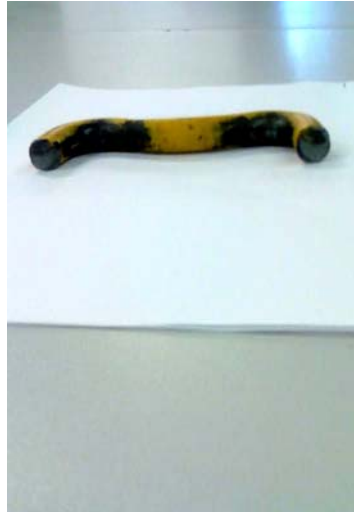
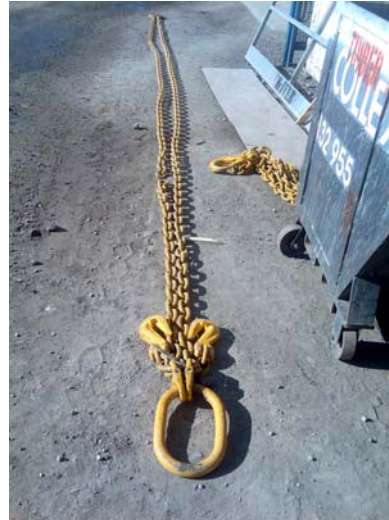
<p><b>Incident Summary</b></p>	<p>On May 23<sup>rd</sup> 2007 N3 crane on the Melbourne Convention Centre Development was being used to straighten a steel beam that was out of level. The crane was using one 16mm G80 GUNNEBO Alloy Chain Sling that was hooked to the beam with a 5 tonne beam clamp.</p> <p>As the crane was slowly taking the weight of the beam in order to position it in the final location the chain failed, in that a single link approximately 1 metre from the oblong main ring has separated and opened at the weld during lifting procedures. The sudden release of the sling from the steel beam that was being lifted caused shock loading to the tower crane.</p>
<p><b>Causes</b></p>	<ul style="list-style-type: none"> <li>• An examination of the chain link reveals a possible internal fault with the weld.</li> </ul>
<p><b>Preventative Measures</b></p>	<ul style="list-style-type: none"> <li>• The 2 leg chain sling (Tag Serial No. BV 1311206.1) and another identical 16mm 2 leg chain sling (Tag Serial No. BV 1311206.2) were immediately removed from service.</li> <li>• WorkSafe have recommended that all yellow GUNNEBO 16mm chain slings that are currently being used on the MCCD Project be replaced and removed from service and returned to the supplier/manufacturer for inspection and testing to ascertain whether there is a fault with this particular batch of chains.</li> <li>• WorkSafe also recommended that all slings on the MCCD Project which have not undergone a recent testing by a NATA approved testing agency (or equivalent alternative competent tester) should be removed from service and retested or replaced with suitable chain slings which have undergone a recent load test. (not just a visual test)</li> <li>• A thorough inspection of the N3 crane was also conducted to check for any possible damage caused by the shock loading.</li> </ul>
