## CONCRETE PUMP LINE FAILURE

To inform all sites of an incident where the fixed steel delivery line on a boom type concrete pump has failed.

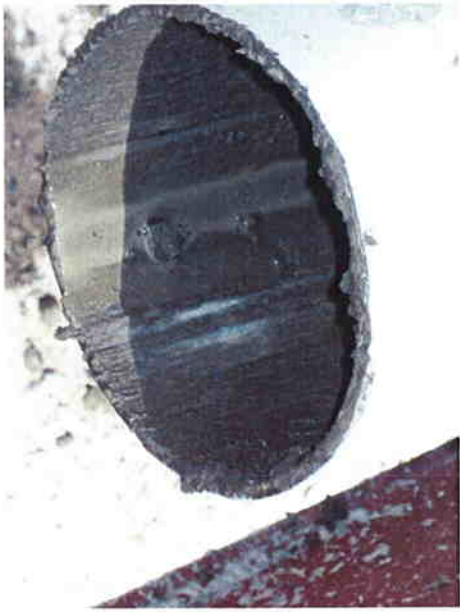
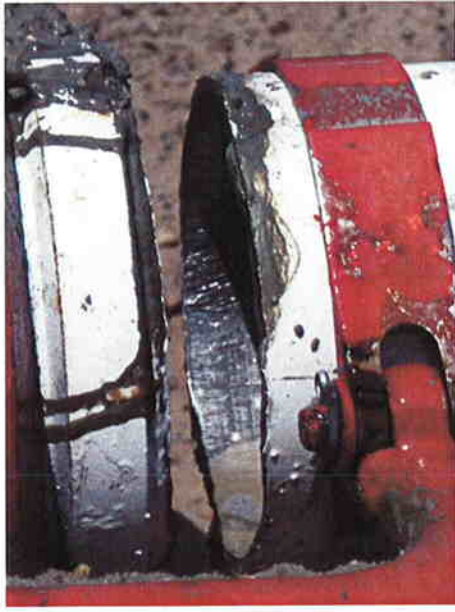
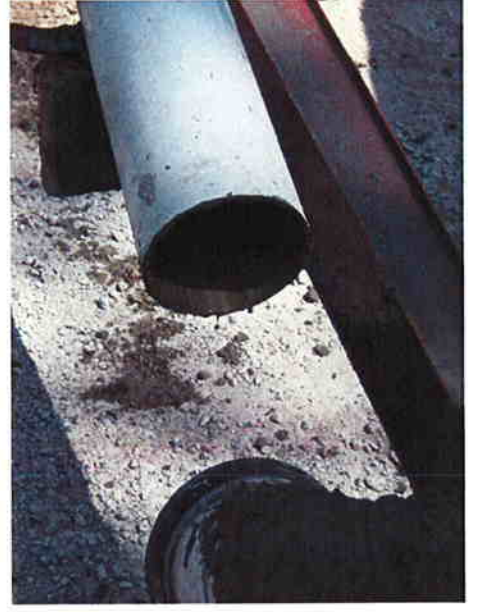
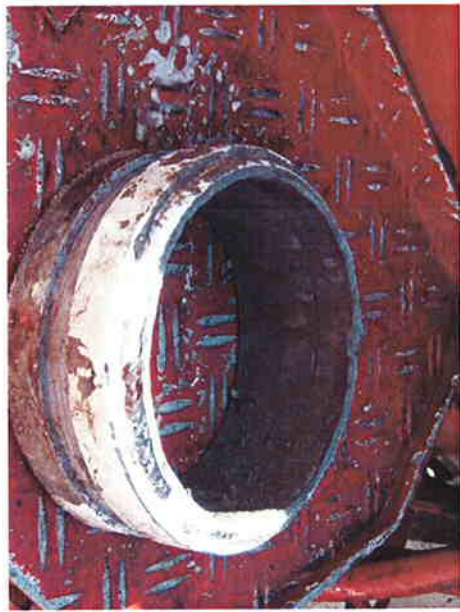
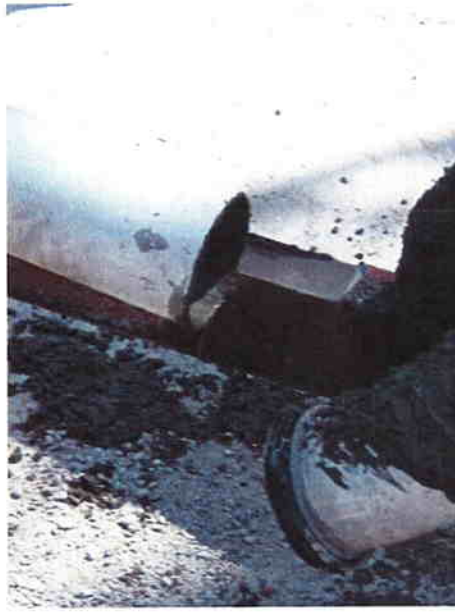
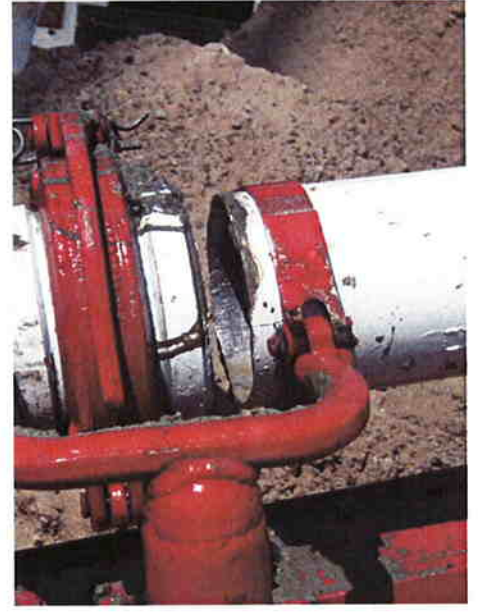
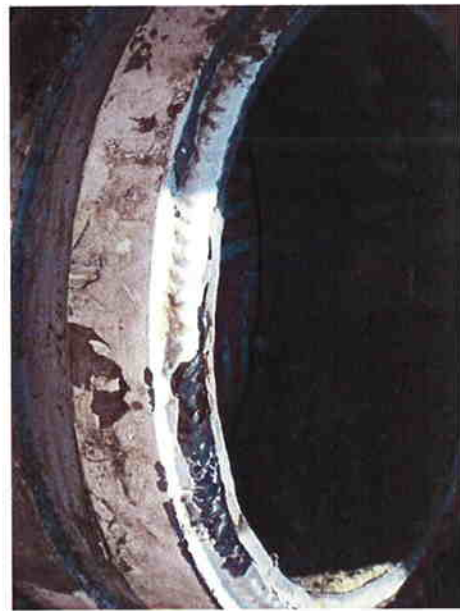
A boom type concrete pump was operating on a site when the fixed steel delivery line has failed in 2 places (photos attached). The line apparently is only about a month old and seems to have failed under normal operating conditions. A few workers were struck with concrete aggregate but no injuries were recorded.

As the pipeline is only a month old it would be pertinent to have all maintenance records for any concrete boom pump used on site. It would also be advisable to check all static lines on a regular basis.

Section 8.4 covers Pipelines and pipeline components and the checking/ testing of these components.
