# REO BAR CAP OFF SAFETY ALERT

Another reminder of the importance of making sure that exposed reo bars are protected with caps. A carpenter was hospitalized after falling and becoming **impaled on a y16 reo bar today**.

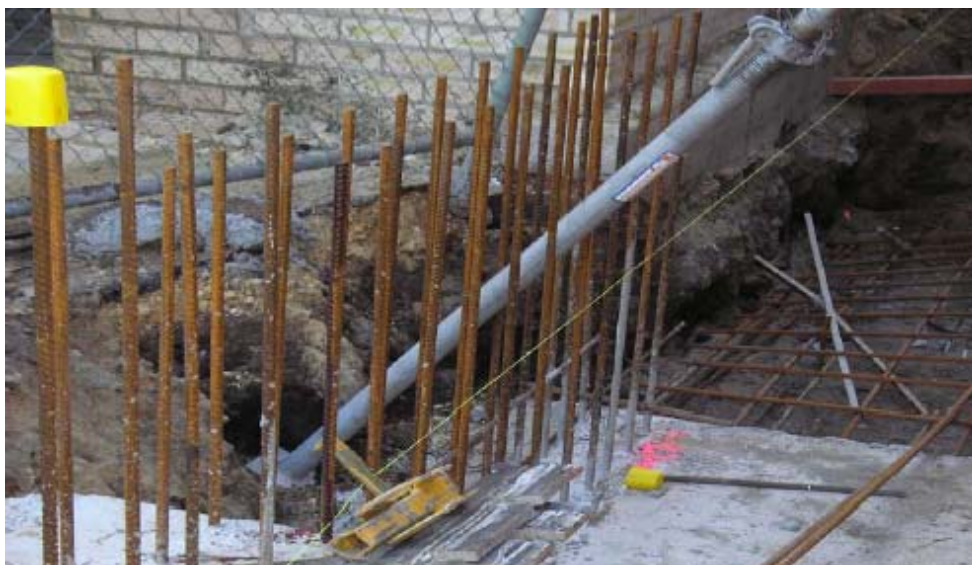
The carpenter fell from a ladder and landed on vertical steel reinforcing starter bar, penetrating his leg and travelling vertically through his thigh.

The carpenter was assisted by workers close by and taken to Royal Perth Hospital by emergency services. The worker also sustained some facial lacerations, narrowly missing his eye from impacting against the reo when he landed.

**A safe system of work for working at heights and reo bars which were capped would have prevented this serious accident from occurring and should serve as a reminder to all sites not to be complacent with exposed reo bars.**
